EVEN HARMONIC RESONANCE- AN UNUSUAL PROBLEM

Copyright Material IEEE
Paper No. PCIC 2002-11

Abstract - The paper is a case study examining the cause, effect and solution of an actual “non-characteristic” even harmonic problem in an electrochemical plant. While issues concerning “characteristic” harmonics are well documented in the literature, limited information is available describing how non-characteristic harmonic currents create operational problems. The author has not found any papers describing a case of even harmonic resonance and would like to share the experience of resolving a 4th harmonic resonance problem in the hopes it will benefit others.

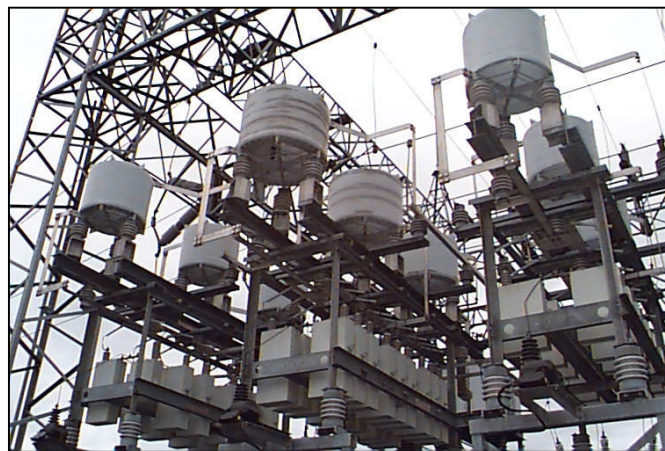
Fig. 1: Line A Harmonic Filter

A call from the plant indicated that they were experiencing what appeared to be overheating of a set of reactors used in a harmonic filter associated with one of the plant’s converter systems. The reactors in the 5th harmonic branch of the filter had discolored, and dark bands were evident on the glass-fiber surface of the reactors.

Measurements demonstrated that with Line B operating, large amounts of 4th harmonic current overloaded the Line A filter 5th branch for short periods. The reactors have little thermal mass, and can reach extreme temperatures in the order of minutes. For at least 13-second periods, the reactors were exposed to a 200% load. If Line B is shut down under these conditions, the currents are likely to be significantly higher. A redeeming feature is that Line B is shut down infrequently for short intervals of maintenance. The cumulative effects of repeated overheating over time has stressed the reactors.

In 1992, one of the 5th harmonic reactors was replaced. This explains why only two of the three existing reactors are showing signs of damage. The newer reactor has not been exposed to the same degree of repeated overheating as the two older fifth harmonic reactors.

Second, redesigned 5th harmonic filter reactors are being installed to move the parallel resonance between the filter and the power system to below the 4th. The new design will greatly decrease the sensitivity to resonance. New reactors have been ordered and the replacement has been scheduled.

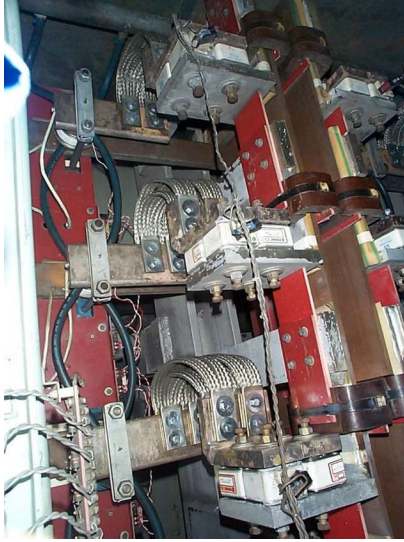
Fig. 4: Line A Rectifier Power Section

So, what was causing the overheating? Additional clues were uncovered as we reviewed the history of rectifier operation. Discussions with plant maintenance personnel indicated that an extensive retrofit of the rectifier power section had recently been completed, with oversize devices installed. This had eliminated the repeated thyristor failures that occurring prior to the retrofit and was a strong indication that the problem was associated with control irregularities.

If firing timing is not identical for a parallel set of thyristors, uneven loading can result producing individual semi-conductor failures and gravitate towards a subsequent cascade of failures through the system as fewer devices carry more and more of the load. By installing larger oversize devices, the plant had eliminated the symptom.

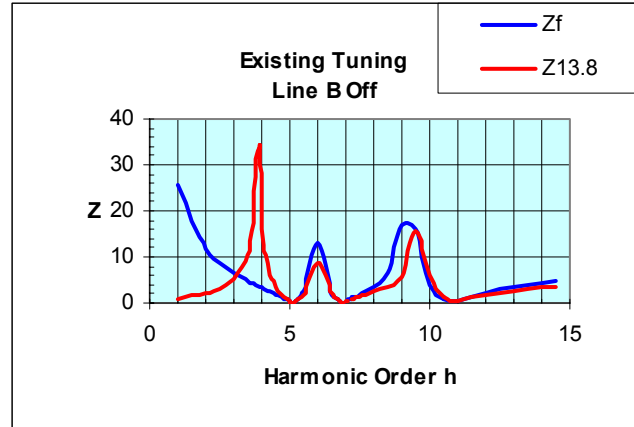
Fig. 5: Series & Parallel Resonance of 5th Filter & 13.8 kV Bus

Various power system configurations used during normal plant operations were checked. An interesting discovery was made when Line A was operating with the Line B rectifier and filter shut down. The 5th filter branch in Line A (series tuned to exactly 300 Hz) was found to exhibit strong parallel resonance with the power system at the 4th harmonic when the Line B system is out of service. When the Line B system is operating, the parallel resonance is still present, but not nearly as significant.

Subsequent analysis indicated that if Line B is shut down and the rectifier produces as little as 5% 4th harmonic current, it is amplified and causes a 40% current overload in the 5th branch of the Line A filter.

The resonant effects of tuning the Line A harmonic filter exactly to each harmonic frequency to be treated was not considered in the original design. Tuning each of the 5th, 7th and 11th branches to a frequency 2% to 10% below the target frequency would have alleviated the parallel resonance.

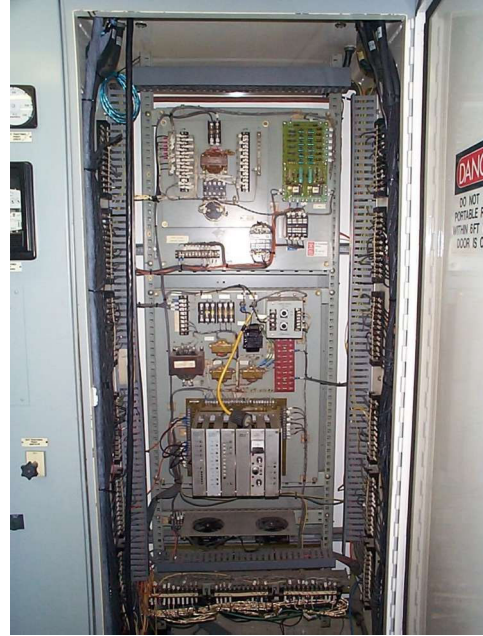
Fig. 6: Line A Rectifier Control System

The origin of the difficulties experienced is a thyristor firing circuit problem. The age of the control system and resulting electronic component “drift”, appears to have created a Type 1 timing irregularity.

The Line A rectifier is over 30 years old and, while well past its original design life, continued operation of these robust machines is common in the electrochemical industry. The Achilles heal of these units is typically the aging electronics of the control system. Electronic equipment has a bathtub-shaped reliability curve and this equipment is likely on the upward slope of that curve. In short, control system problems are to be expected with older rectifiers.

The installation of a new rectifier control system is a substantial capital expenditure, and the plant is now

considering this step. In the meantime, the following measures have been put into place.
