## WHAKAMARU POWER STATION REHABILITATION PROJECT

Author: Glen Twining, PMP, RMU Program Manager - Whakamaru, Mercury NZ Ltd, New Zealand.

### ABSTRACT

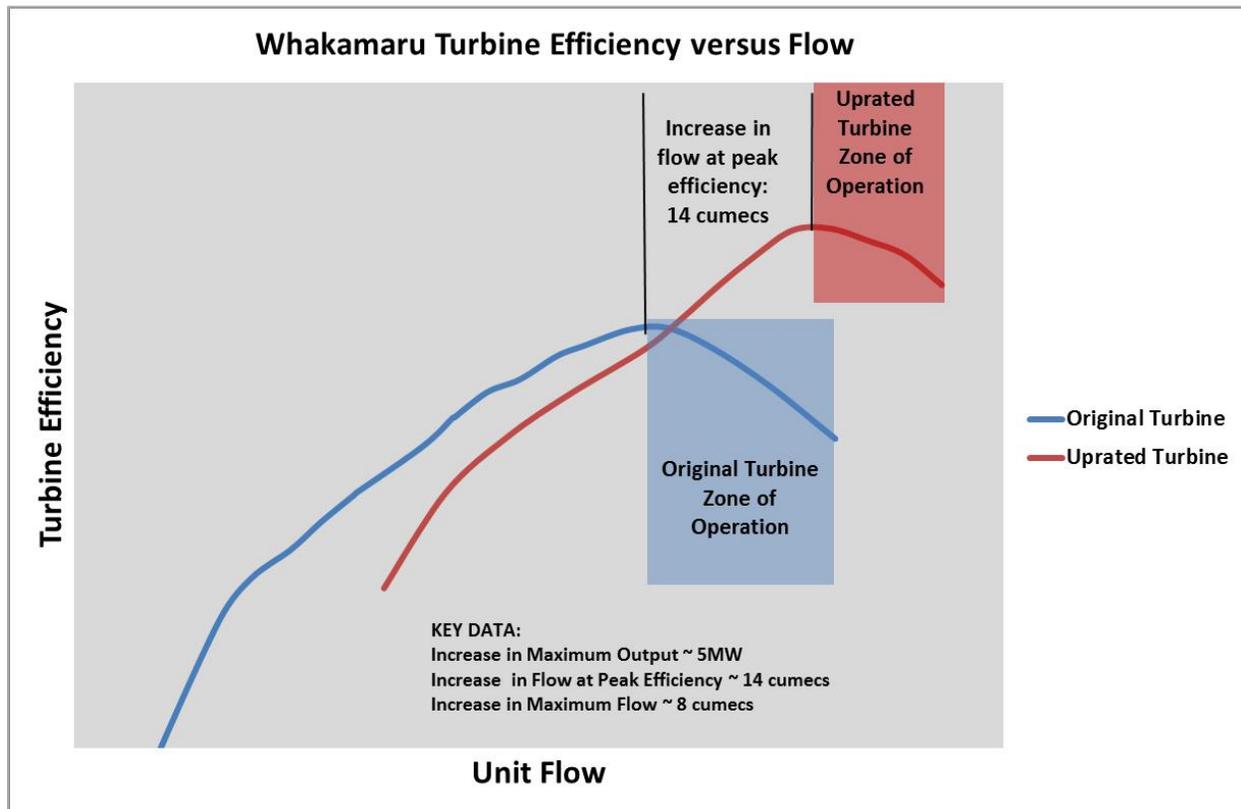
Figure 3: Whakamaru Turbine Original vs. Uprated Comparison

During the early feasibility and planning stages of the project, a Registration of Interest process was run where expected uprated performance figures were submitted by potential suppliers. Using in house resource, the expected performance curves were run through Mercury’s Waikato hydro system model to determine the best configuration for the Whakamaru units. The selected option sees the turbine flow at peak efficiency increased by 14 m<sup>3</sup>/s, the peak turbine flow increased by 8 m<sup>3</sup>/s, the turbine output increased by approximately 5 MW and an efficiency increase. **Figure 3** shows the original and uprated turbine curves and outlines the key differences.

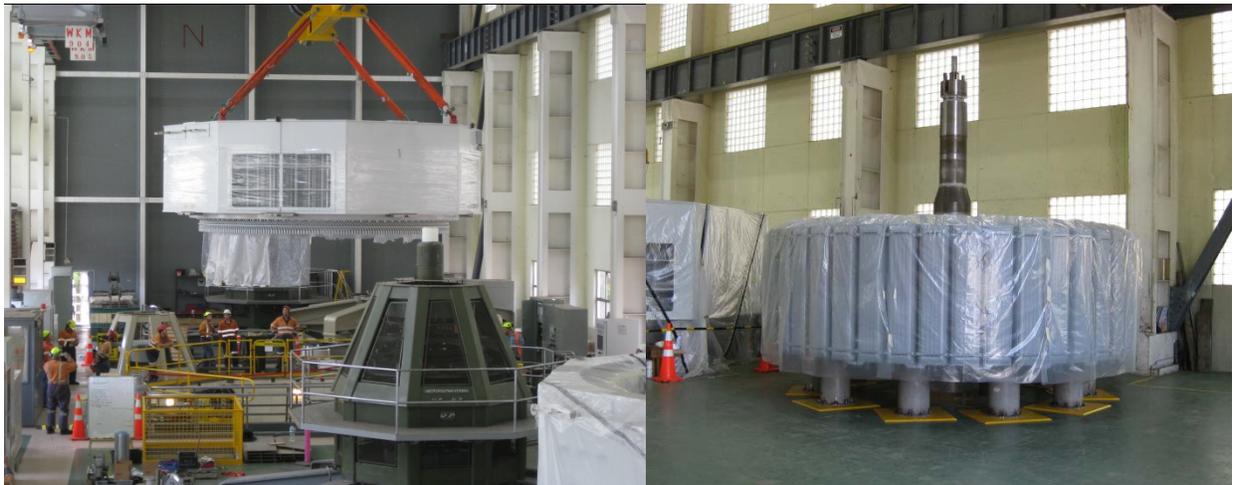
**Figure 4: New Stator Installation and Refurbished Rotor for Unit 3**

The generator work includes complete replacement of the stators, replacement of rotor poles, relocation and rebuilding of the slip rings and replacement of the rotor leads system. Interfacing a new through shaft turbine air admission system into the machine resulted in a rotor lead system not seen before by the Mercury team. This presented additional challenges for implementing the refurbishment work on the generator to accept the new parts.

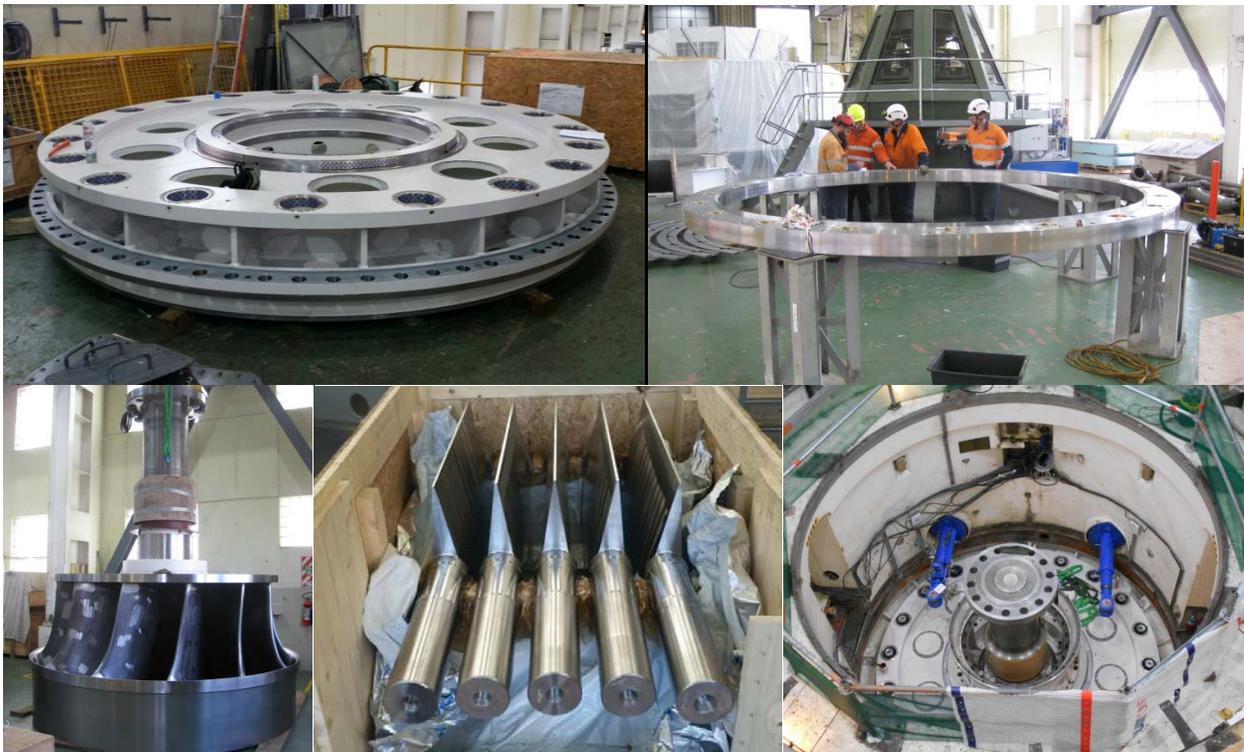
**Figure 5: New Turbine and Governor Components for Unit 3**

The turbine work includes the replacement of the headcover, bottom ring, turbine runner, wicket gates and shaft seals. A through shaft air admission system was designed and installed. All original bearings were retained, including the thrust bearing.

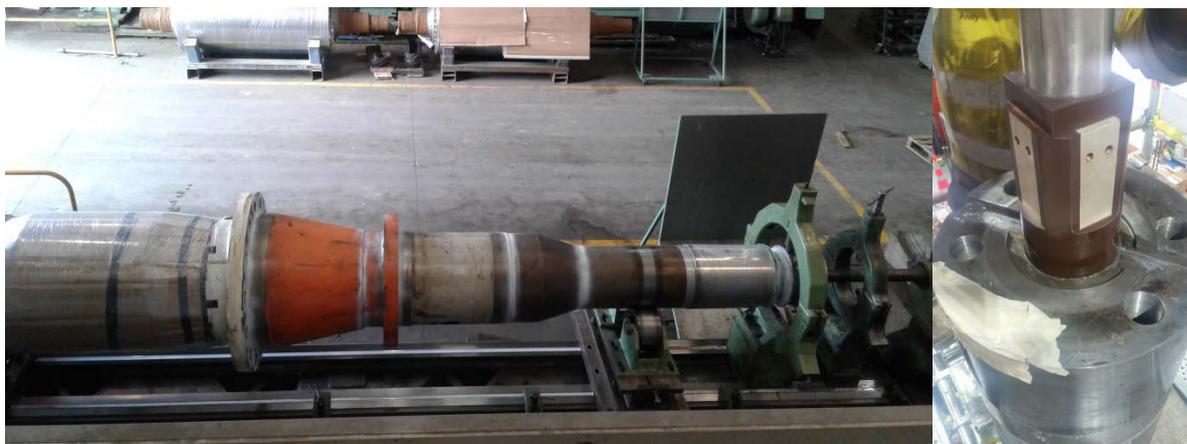
**Figure 6: Generator Shaft Boring (Left), Post-Modification with Shaft Connection Sleeve (Right)**

There were also some technical challenges identified in the site works where a failure to execute correctly would have a large impact on project time and cost, and significant business interruption given the nature of Whakamaru in the hydro scheme. Increasing the diameter of the generator shaft bore over approximately half its length for the new rotor leads shaft connection sleeve assembly provided a technical challenge for the installation contractor and their subcontractor. Mercury considered this work a risk to time and cost and together with the installation contractor a trial was completed to fully develop the machining procedure and fine tune tooling and feed rates to meet the tolerances required for the new equipment. This piece of risk management work demonstrated its value as the work on the actual generator shaft was completed in eight days and the shaft was installed back into the rotor ahead of schedule for the rotor refurbishment works to be completed by the generator equipment supply contractor. The installation of the new rotor leads shaft connection sleeve was completed as shown in the right hand side of **Figure 6: Generator Shaft Boring (Left), Post-Modification with Shaft Connection Sleeve (Right)**.
