From old to new in nine days

Even though headboxes are designed to work in demanding environments, their performance will degrade over the years as heat, chemicals, moisture, and vibration take their toll. A total reconditioning of a pair of headboxes on a board machine in only nine days – from de-install to re-install – sounds like a mill manager's daydream. But it was a reality at Mayr-Melnhof's Gernsbach mill in Germany.

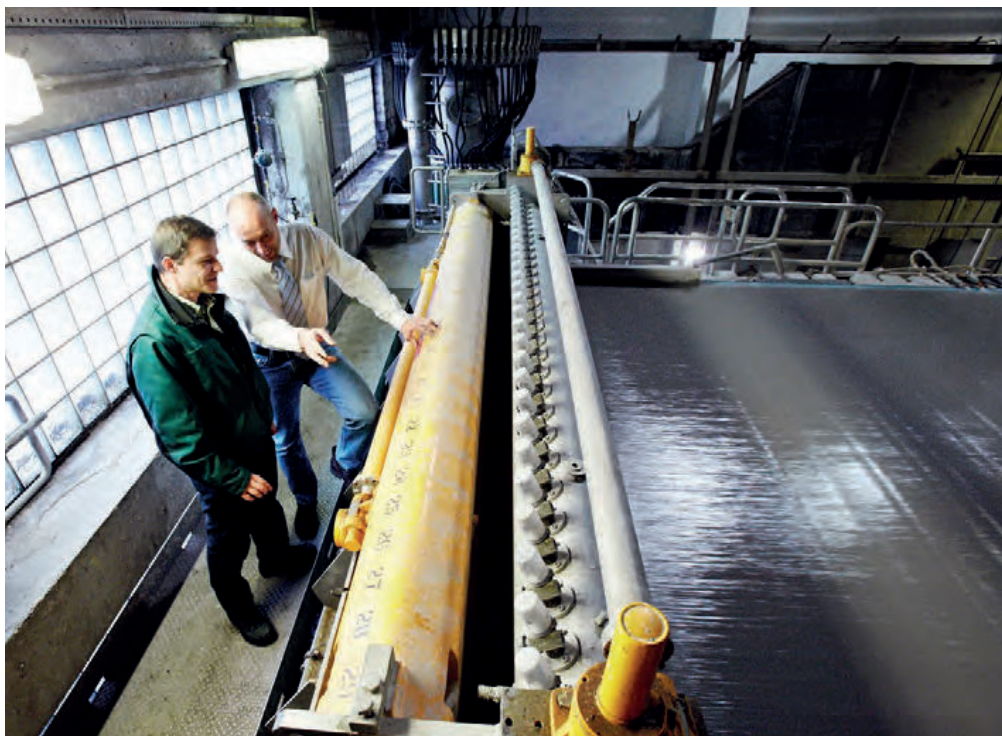
◀ Nagel and Kraxner with one of the four reconditioned headboxes. In addition to safe and stable production for future years, the headbox reconditioning improved the quality of the sheet by enabling better CD moisture profile control.

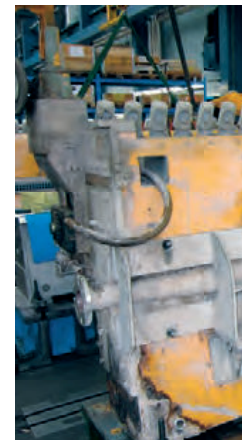
The headboxes were from the early 1990's. According to Johannes Kraxner, ANDRITZ's Product Manager for Paper Machine Services, the standards and materials used in headboxes in 1990 were quite different than for today. "Some of the chemicals used today have a negative effect on a headbox built 23 years ago," Kraxner explains. "The protective coating on the metal gets dissolved or abraded, which fuels corrosion."

▼ Headbox (before reconditioning).

Technicians and machinists were ready for the arrival of the headboxes in Graz. They moved quickly into action to completely disassemble the headboxes, sandblast and paint all the steel parts, clean the stainless steel and bronze parts with a ceramic blast, plane and grind the bottom and top slice lips, and exchange all the gearboxes used for adjusting the profile.

The machinists also manufactured new headbox tables and produced new base frames for the bottom layer headboxes to replace the corroded ones. After assembling and adjusting all components, the "new" headboxes trucked back to Germany and installed back into KM2.
