A new system for a known phenomenon

Auto-oscillation protection by ANDRITZ Hydro

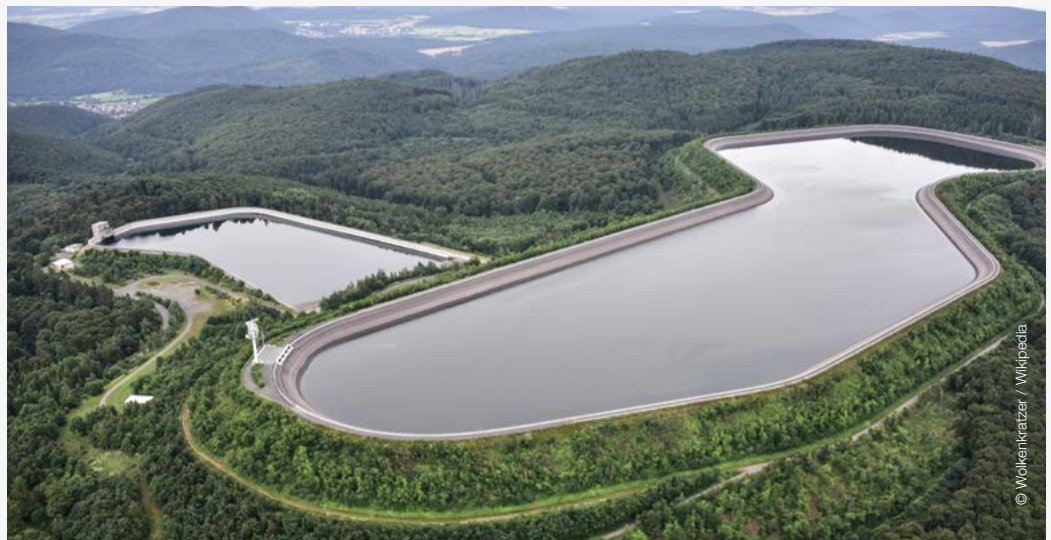
Uniper Kraftwerke GmbH / Germany has installed the systems in PSPP Waldeck 1 (one 70 MW pump turbine) and Waldeck 2 (two ternary units each 240 MW) in 2017
