RECONDITIONING SERVICE FOR ALL BRANDS

Enhancing performance, extending lifetime and improving sheet quality

ANDRITZ headbox reconditioning service for all brands of headboxes

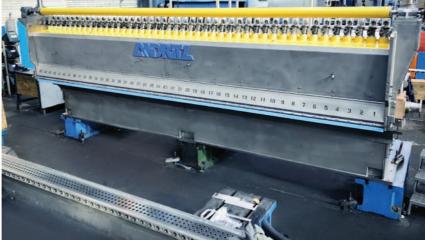
Headbox of a paper machine before rebuild

Headbox after ANDRITZ reconditioning service

By installing new heating channels, repairing or entirely replacing the slice and apron lips, exchanging various worn-out elements, and conducting final precise adjustment of all of these components, a stabile sheet profile can be restored.

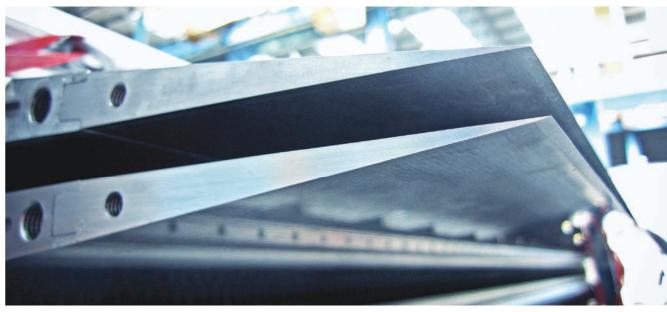
Headbox after ANDRITZ reconditioning service
