MAKING IT ALL

ADD UP

ANDRITZ has recently completed a service at Mayr-Melnhof's FS Karton mill, involving one MG cylinder, two web stabilizers, three dryer cylinders, and a fourth headbox service. From order to completion, it all added up to four service operations in just four months. So – did it all go by the numbers?

In January 2017, ANDRITZ carried out a suite of service upgrades on the 350,000-tonne BM5 at Mayr-Melnhof's FS Karton mill in Neuss, Germany, the largest recycled boxboard machine in Europe.

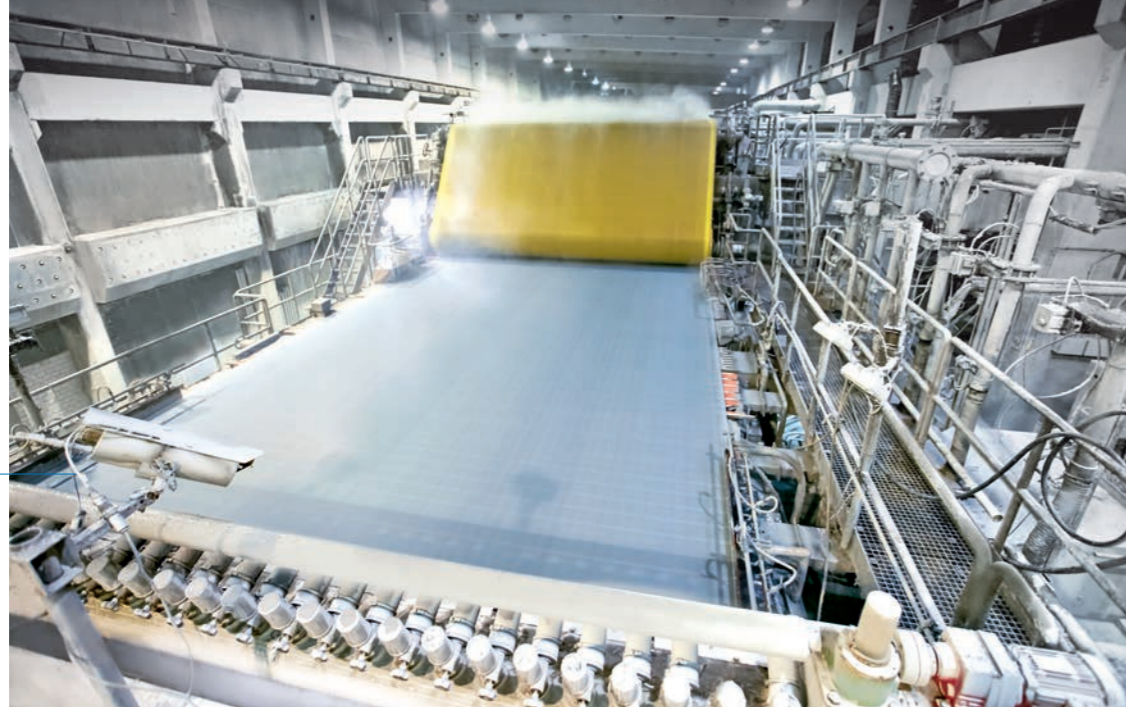
ANDRITZ has now serviced all four headboxes at Neuss during the past five years. The most recent upgrade was for the filler ply, which restored the headbox's full technical functionality, enabling it to reach the desired process and quality parameters.

BM5 uses four fourdrinier formers to make its boxboard - first top layer, second top layer, filler layer, and back layer. ANDRITZ recently revised the headboxes for three of the four formers and completed the full set this January, bringing the headbox for the filler ply back up to date. Johannes Kraxner, Service Manager, ANDRITZ Tissue, Paper & Board Machines, notes that the headbox had already far outlasted its design expectations, "For example, you would normally change the diffuser inserts every 8-10 years, but these had lasted 16 years!"

As part of a full headbox service, ANDRITZ installed new bottom and top slice lip and renewed all seals. "We took it completely apart," Kraxner explains, "which has given us benefits such as improved cross-direction and machine-direction basis-weight control and correct sealing on the mixing chamber right from the start-up. The upgrade has restored full technical functionality to the headbox, enabling it to reach the desired process and quality parameters."
